Manhole Inspection Summary

Manhole # S17II1008MH

Insp Date: **1/11/07 10:55 AM**

Location Address: **EDGEHURST RD**

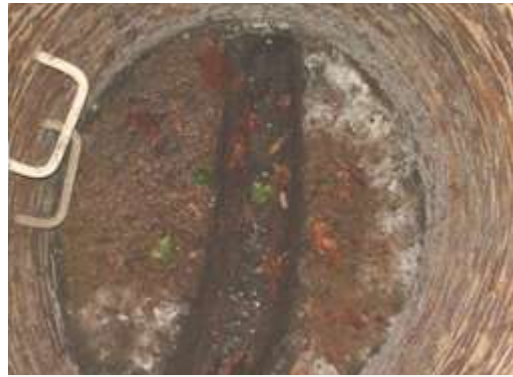
Top View

Evidence of surcharge - Bench debris.
Channel debris.

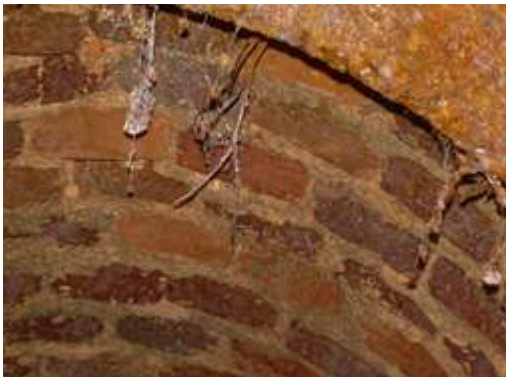
Defect

Condition: ☐ Sound ☐ Cracked ☒ **Root Intrusion** ☐ Loose Brick ☐ Deteriorated

Infiltration: ☐ None ☒ **Joint** ☐ Cracks ☒ **Mortar** ☒ **Roots** ☐ Wall

Adjustment root intrusion and infiltration.

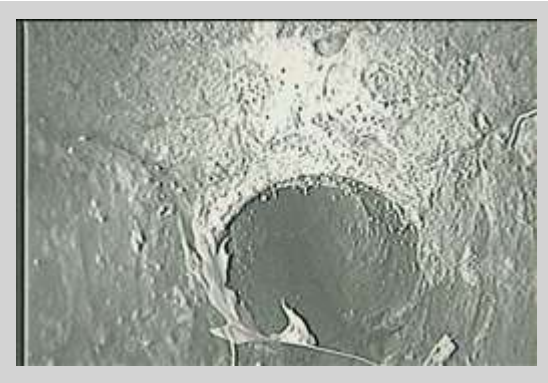
8 in. Circular Gravity Sewer Pipe Out @ 12 O'Clock

Infiltration: **None** Pipe Seal Cond: **Roots**

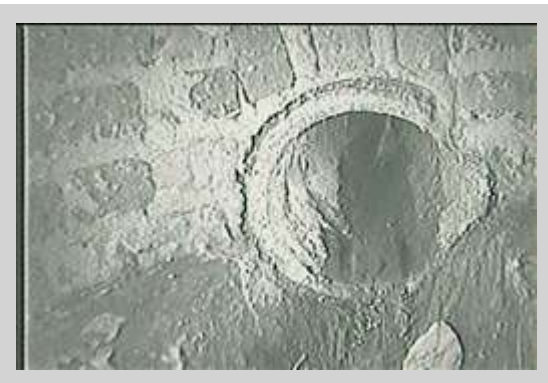
8 in. Circular Gravity Sewer Pipe In @ 7 O'Clock

Deposits: ☐ None ☐ Mud ☐ Sludge ☐ Debris ☒ Grease

Silt Depth: **0** (in.) Deposits Extent: **Light**

Infiltration: **Evidence** Pipe Seal Cond: **Unknown**
